IRS RESEARCH SAFETY VEHICLE TO 1979 DODGE FRONT-ENGINE CRASH TEST REPORT—FRONTAL ALIGNED IMPACT AT 86.52 MPH CLOSING SPEED

R. Baczynski
T. Bjork
S. Davis

Dynamic Science, Inc.
A Talley Industries Company
1850 West Pinnacle Peak Road
Phoenix, Arizona 85027

FEBRUARY 1981
TEST REPORT

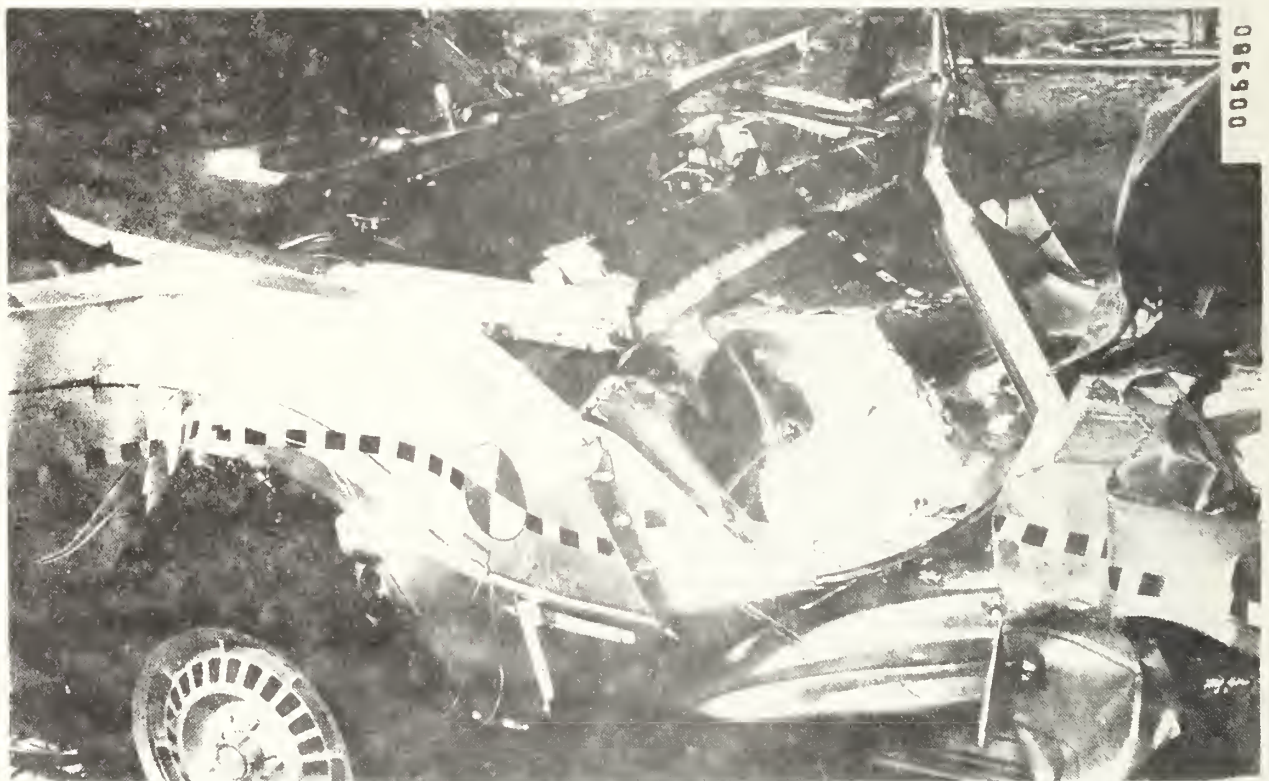
FIGURE C-1. POST-TEST VIEW OF MINICARS RSV
RIGHT FRONTAL AND SIDE DAMAGE.

Glazing: Windshield cracked completely. Retention loss from a point 11.5 inches right of C, at top, down right side, and across bottom to bottom corner on left side, except for 2 inches retained on right side bottom rear right corner. Right side door main window cracked over entire surface.

Doors: Right side door opened during crash due to failure of the five rivets holding the latching mechanism to the door. Left side door required tools to open after test, and opened when the corresponding five rivets failed.

Miscellaneous: No fuel system leakage. Coolant leakage observed. Hood flew off. Rear view mirror came off. Moderate floor pan intrusion.
